THE NEALE COMPRESSOR PLANT SITE MERRYVILLE, LA

REMEDIATION ACTIVITIES AND ASBESTOS ABATEMENT

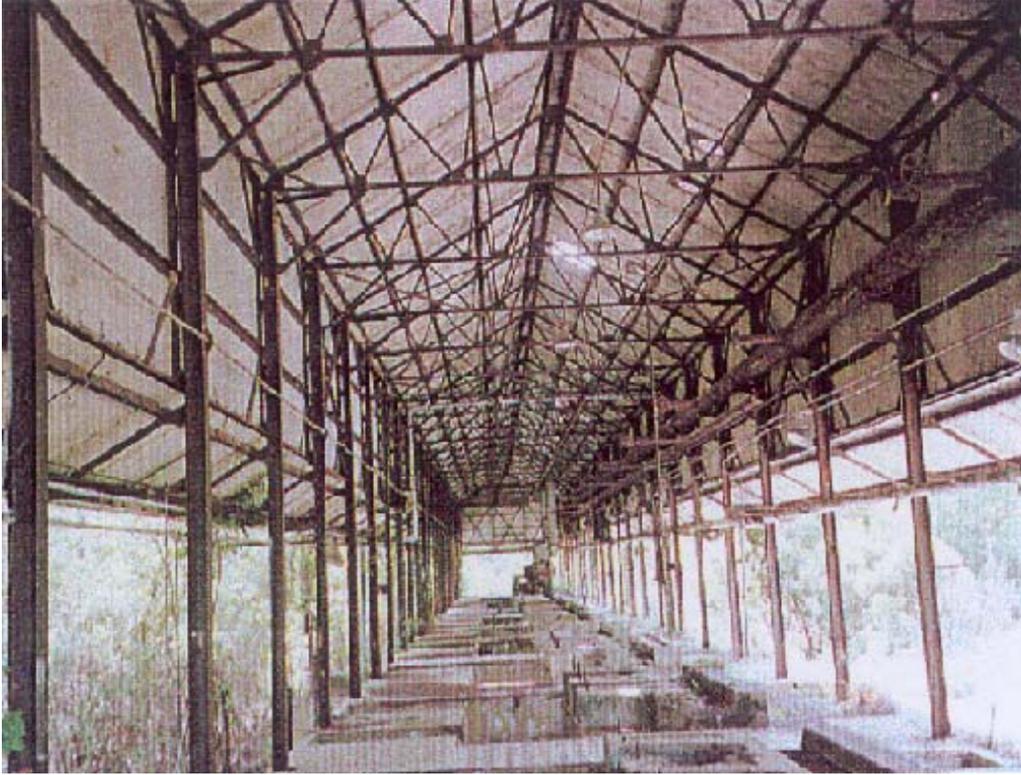
Neale Compressor Site – Large Compressor Building Before

Remediation of this area consisted of removing ACM transit wall/roofing panels and glove bagging the wet material/debris on the floor including the sumps and pit areas. One circuit panel was removed and a dysfunctional electrical circuit box was abated. The building equipment insulation, which included two diesel compressor engines, engine stacks, areas around accesses and insulation on engine housings, was abated. The surface of the large compressor building floor, including the sump and pit areas were vacuumed and the material was placed in bags and properly removed to the disposal facility.

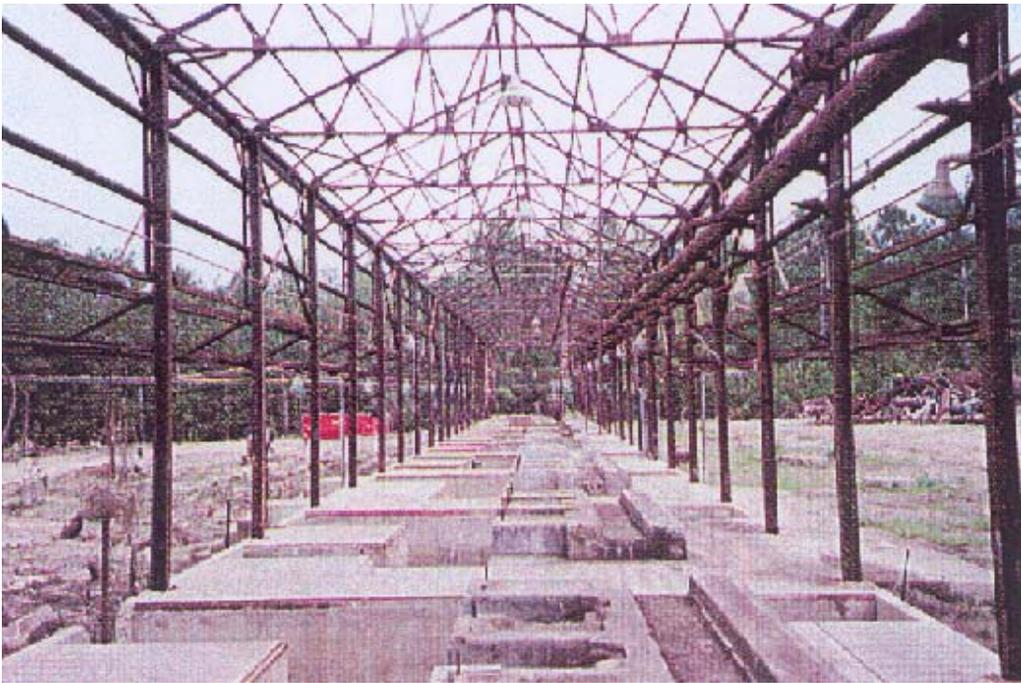
Neale Compressor Site – Large Compressor Building After

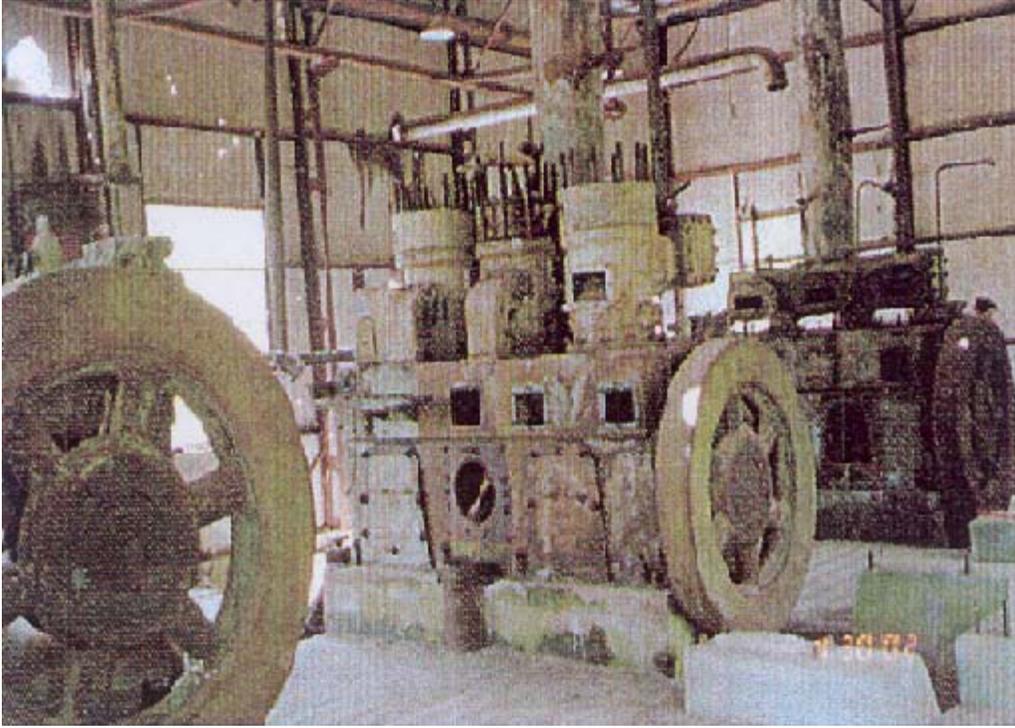
Neale Compressor Site – Small Compressor Building Before

Remediation of this area consisted of removing ACM transite wall/roofing panels. The building equipment insulation, including two diesel compressor engines, engine stacks, and areas around accesses and on the engine housings was abated. The surface of the floor, including the sump and the pit areas were vacuumed and the wet asbestos containing materials and debris was placed in bags and properly removed to the disposal facility.

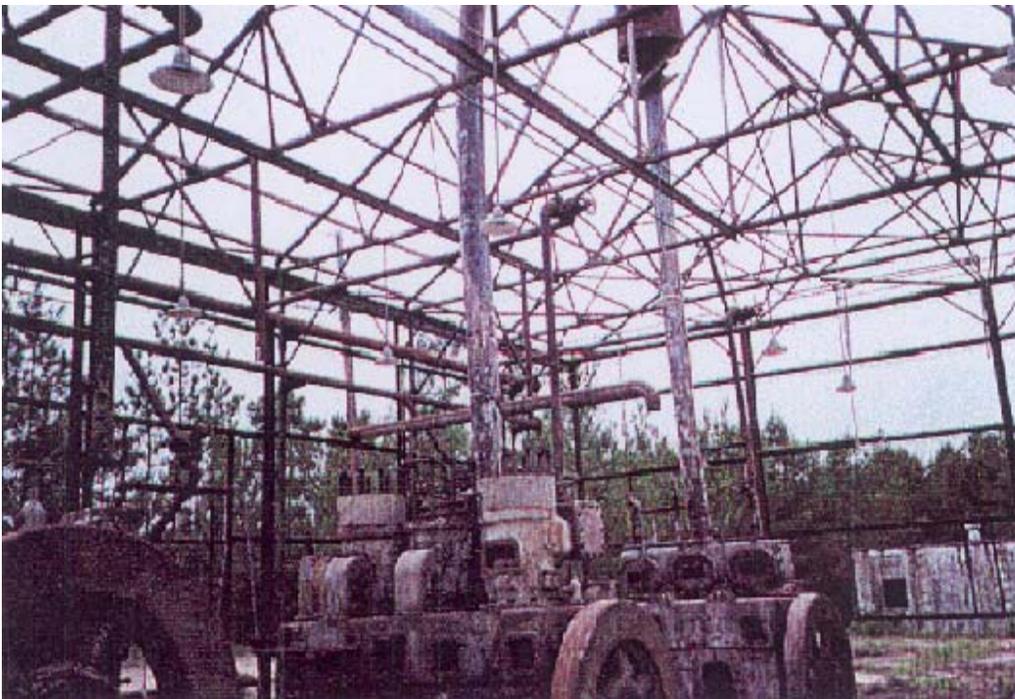
Neale Compressor Site – Small Compressor Building After

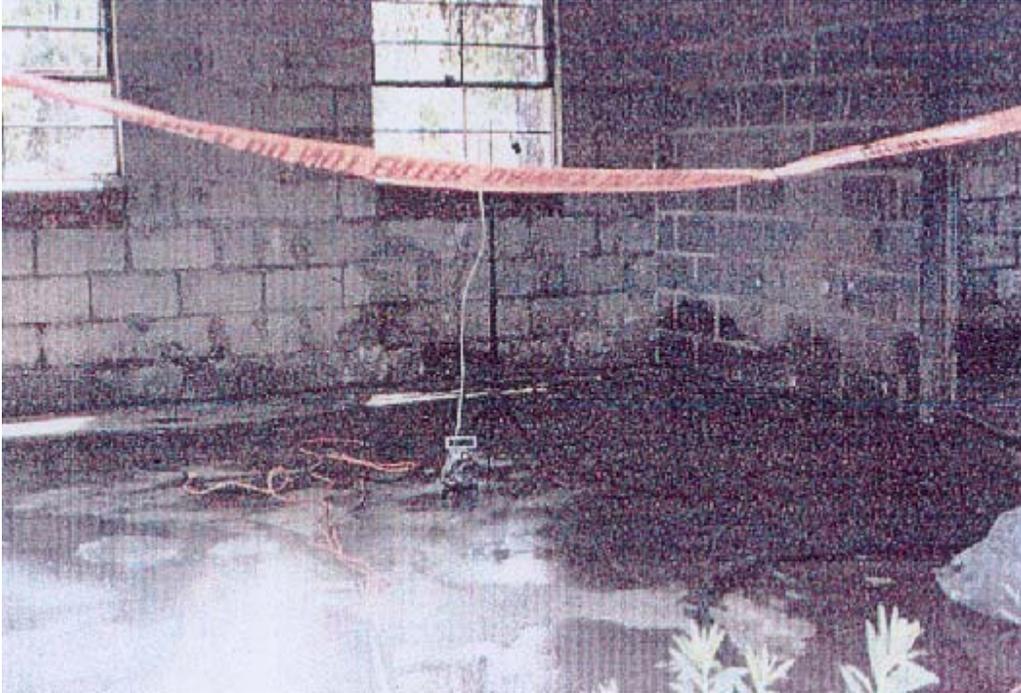
Neale Compressor Site – Maintenance Building Before

Remediation of these areas consisted of wetting the ACM material/debris on the floor prior to glove bagging. The surface of the floor in the area was vacuumed and the vacuumed materials were placed in bags and properly removed to the disposal facility.

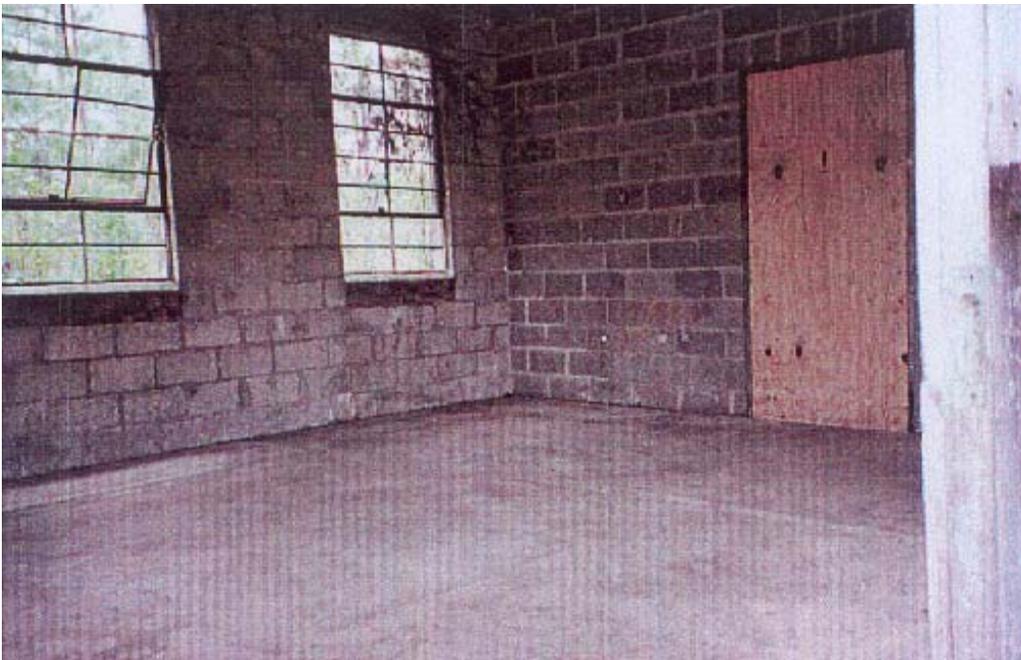
Neale Compressor Site – Maintenance Building After

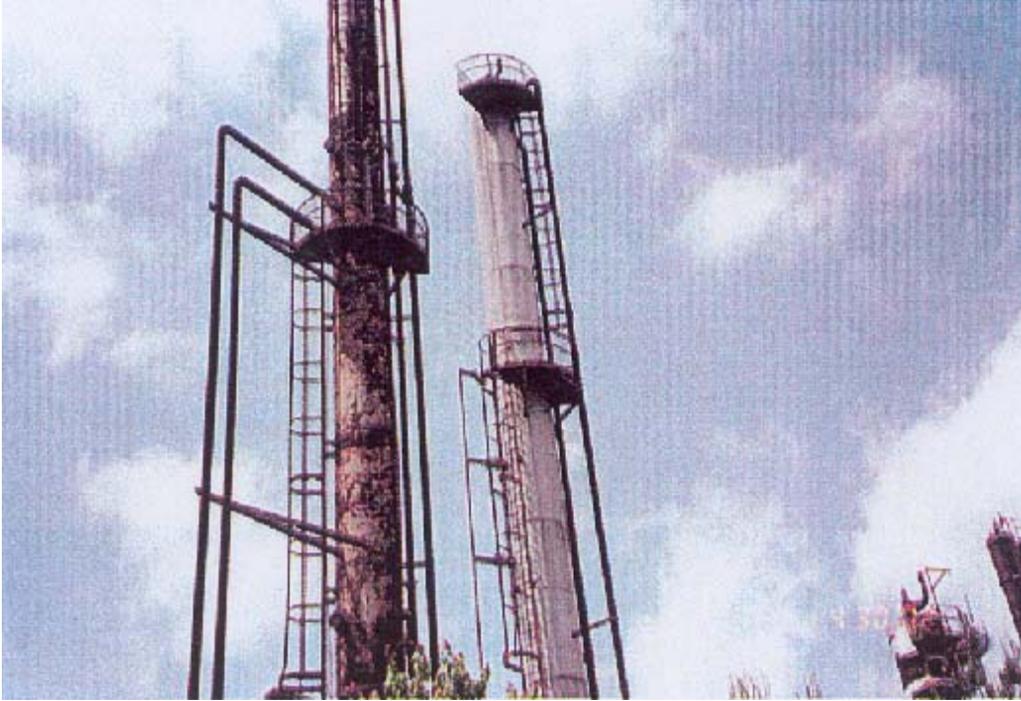
Neale Compressor Site – Frac Towers Before

Remediation of these areas consisted of the removal of Thermal System Insulation–Asbestos Containing Materials (TSI-ACM), friable materials that lined the exterior surfaces of the towers. TSI-ACM was also removed from the base of Tower 2 as well as from covered vertical pipelines associated with Tower 1, Tower 2, and Tower 3. While removing the TSI-ACM, one-foot sections of the pipelines were exposed at ten-foot intervals. The insulated sections were wrapped securely with 6-mil poly sheeting and the

pipelines were cut at the middle of the exposed one-foot sections to allow for handling of the contaminated ten-foot sections. The surfaces of the towers were washed and the wash water was filter cleaned. The filters were disposed as ACM waste. The wrapped sections were labeled, staged, and removed to the waste disposal facility.

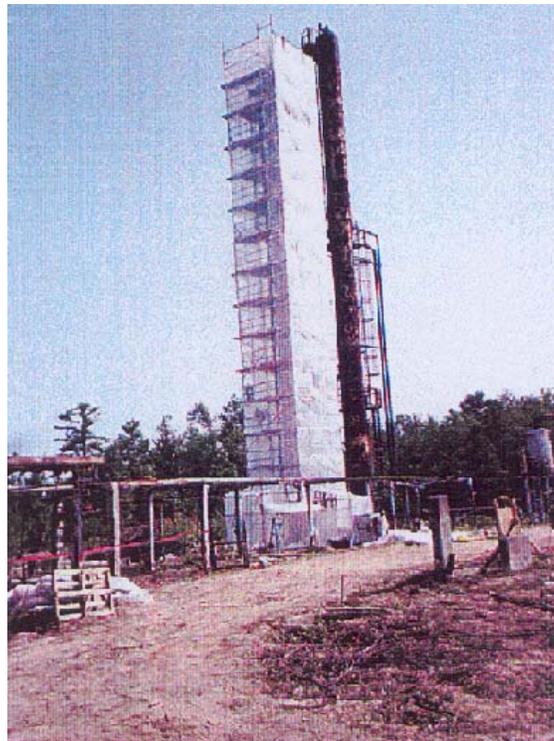
Neale Compressor Site – Frac Towers During (Reverse View)
