LOUISIANA DEPARTMENT OF ENVIRONMENTAL QUALITY

Big Creek (Headwaters to Tangipahoa River)

Subsegment 040703

2012

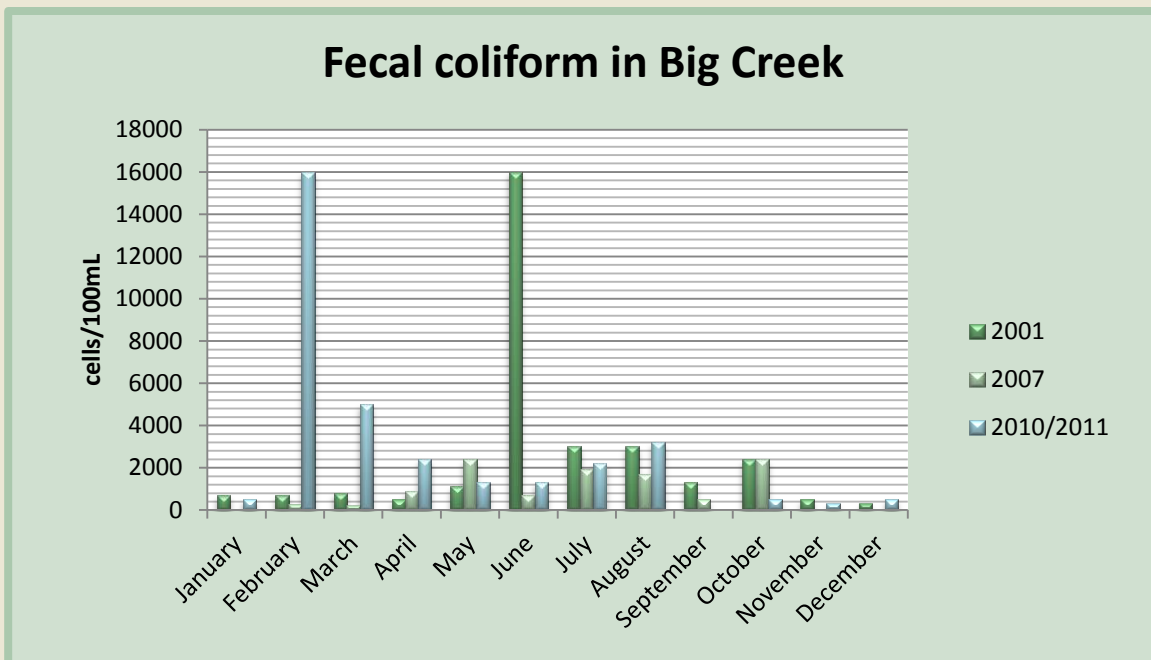
Figure 4: Fecal Coliform in Big Creek 2001, 2007 and 2010/2011

LDEQ collected ambient water quality data in Big Creek at the base of the subsegment for four (4) years between 2001 and 2010/2011. These data indicated that during 2001, fecal coliform concentrations exceeded the state's water quality standard for PCR between May and October. The water quality standard for SCR was exceeded for four (4) of these six (6) months, with a spike of 16,000 cells/100 mL in June 2001.

Similarly, water quality data collected in 2007 also indicated the state's water quality standards for PCR were exceeded between May and October. Water quality standards for SCR were exceeded in May and October. Similarly, water quality data collected between October 2010 and September 2011 indicated water quality standards for PCR were exceeded from May through August of 2011 and in October of 2010. Water quality standards for SCR were exceeded during February, March, April, July and August, with a spike of 16,000 cells/100 mL in February.

Water quality data collected by LDEQ and Lake Pontchartrain Basin Foundation (LPBF) exceeded the state's fecal coliform bacteria standards for PCR. LDEQ's water quality data indicated PCR standards were exceeded between May and October of 2001 and 2007. PCR exceedances also occurred in October 2010 and September-October 2011. LPBF's water quality data also indicated PCR exceedances between May and October of 2008 and 2009. LDEQ's data indicated peak concentrations of 16,000 cells/100mL sample in June 2001 and February 2010, while LPBF's data indicated a peak concentration of 16,000 cells/100mL in January 2007. LDEQ's water quality data also indicated SCR standards were exceeded from May to October of 2001 and in May and October of 2007. SCR standards were also exceeded from February through April and July through August of 2011, with a peak concentration of 16,000 cells/100mL in February.

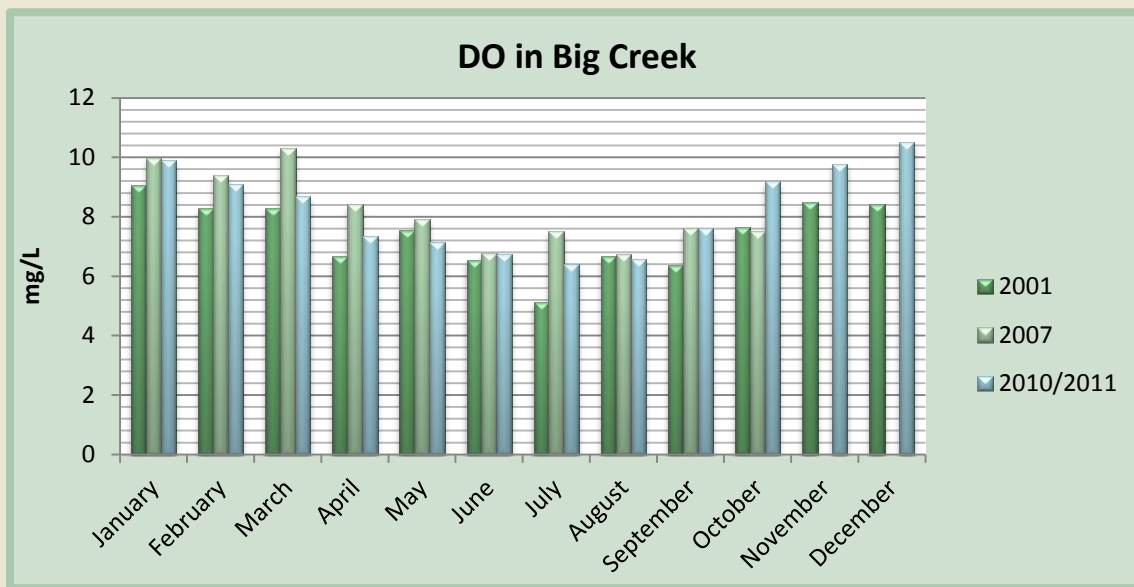
Figure 5: DO in Big Creek 2001, 2007 and 2010/2011

LDEQ's ambient water quality data for Big Creek indicated DO concentrations were maintained and did not exceed the state's 5.0 mg/L water quality standard for DO in Big Creek.

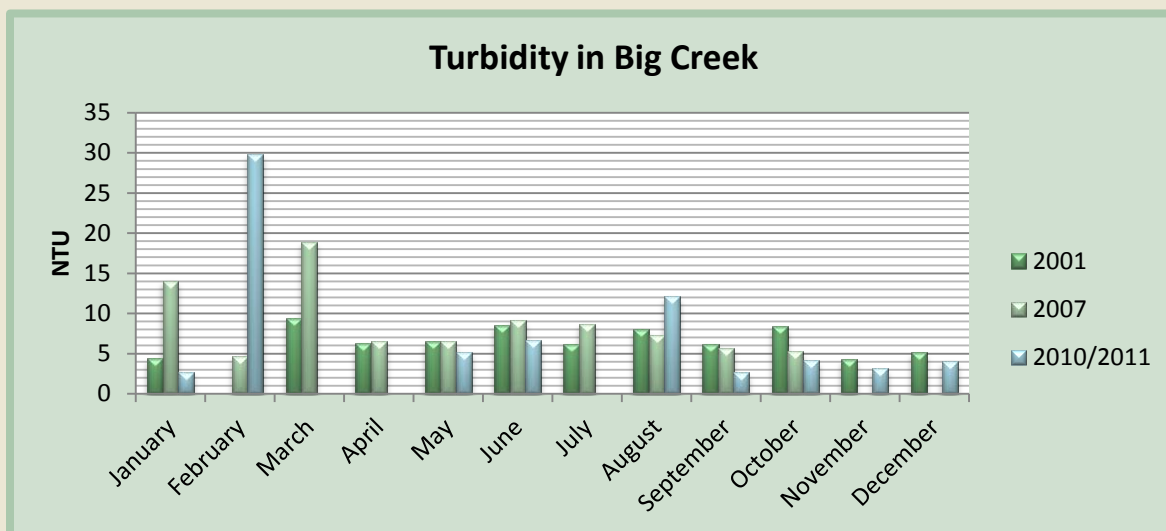
Figure 6: Turbidity in Big Creek 2001, 2007 and 2010/2011

The water quality data for Big Creek indicated that the state's guidelines for turbidity were maintained at or below 50 NTU, but a recent spike in February 2011, indicated potential problems with turbidity. Several sites in the watershed had signs of erosion problems, therefore addressing this issue is one goal of the project.

the state's guidelines of 50 Nephelometric Turbidity Unit (NTU) with the highest turbidity value of 29.8 NTU occurring in February 2011. LPBF's water quality data indicated turbidity values remained below 50 NTU except in January and April of 2009, with values of 55 and 69.19 NTU, respectively. During reconnaissance surveys, erosion problems were observed at several locations, potentially causing turbidity in Big Creek.

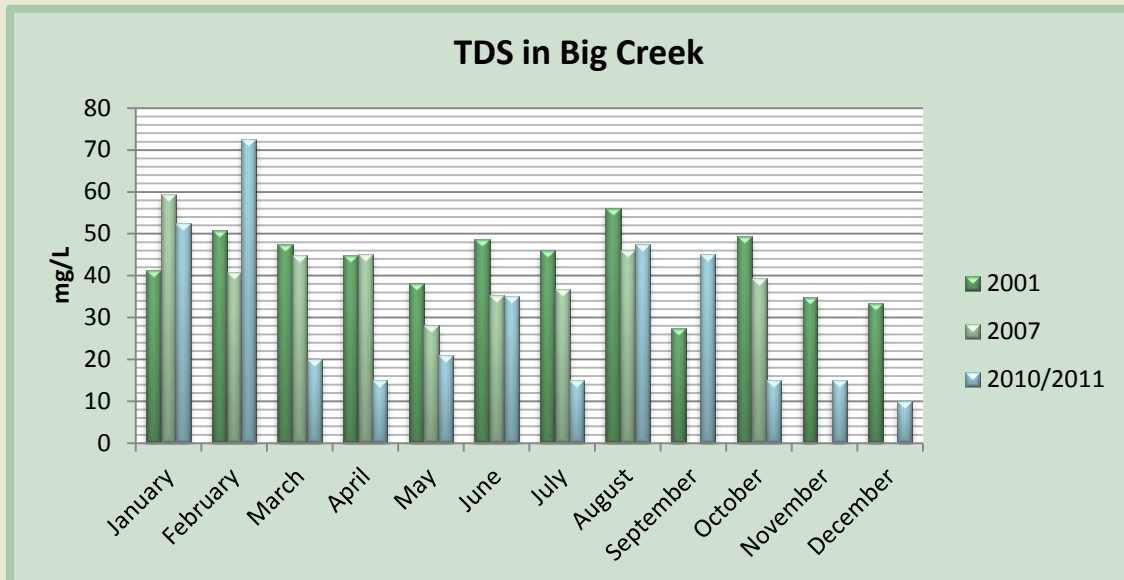
Figure 7: TDS in Big Creek 2001, 2007 and 2010/2011

The water quality data for Big Creek indicated TDS remained below the state's water quality standard of 140 mg/L.

LDEQ's water quality data indicated total dissolved solids (TDS) remained below the state's water quality standard of 140 mg/L. A peak concentration of 40.5 mg/L TSS occurred in March 2007, while lowest TSS concentrations occurred in February 2007, November 2010 and January 2011.

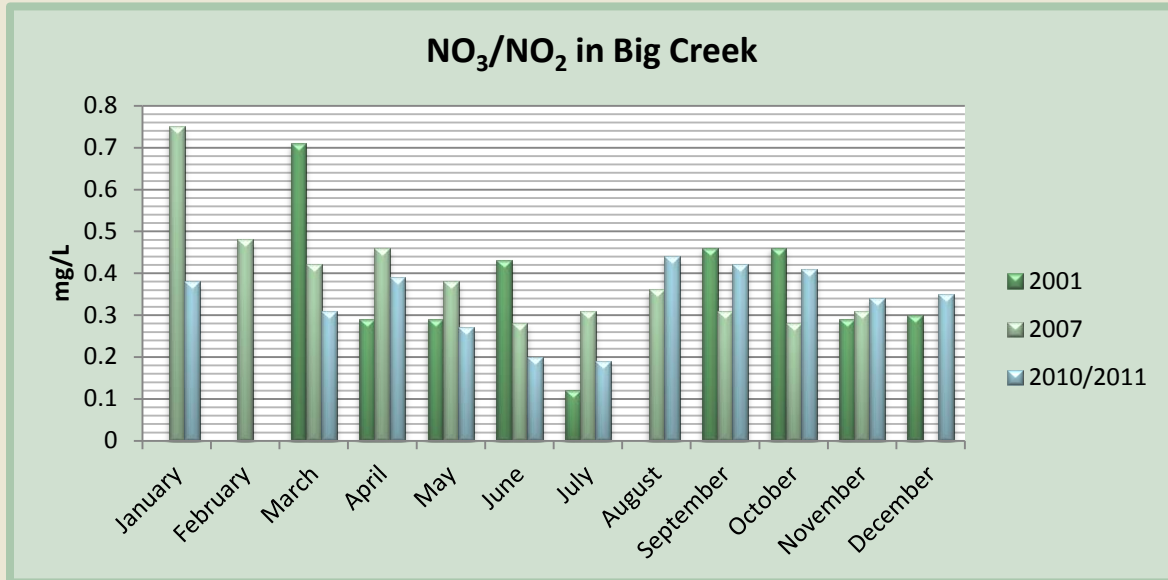
Figure 9: NO₃/NO₂ in Big Creek 2001, 2007 and 2010/2011

The highest value of NO_3/NO_2 in Big Creek occurred in January 2007 (0.75 mg/L), while the lowest value occurred in July 2001 (0.12 mg/L). The highest value of TKN occurred in August of 2011 with a value of 1.74 mg/L. The lowest values or non-detects occurred during October, November, and December of 2010 and January, March, September, and April of 2011.

LDEQ's water quality data indicated the highest concentration (0.75 mg/L) of NO_3/NO_2 occurred in January 2007, while the lowest concentration (0.12 mg/L) occurred in July 2001. The highest concentration (1.74 mg/L) of total kjeldahl nitrogen (TKN) occurred in August 2001, while the lowest concentrations occurred from October through December of 2010, January through April and in September of 2011. The highest concentrations (0.42 mg/L) of TP occurred during February 2001, while lowest concentrations occurred in November 2010 and March 2011.

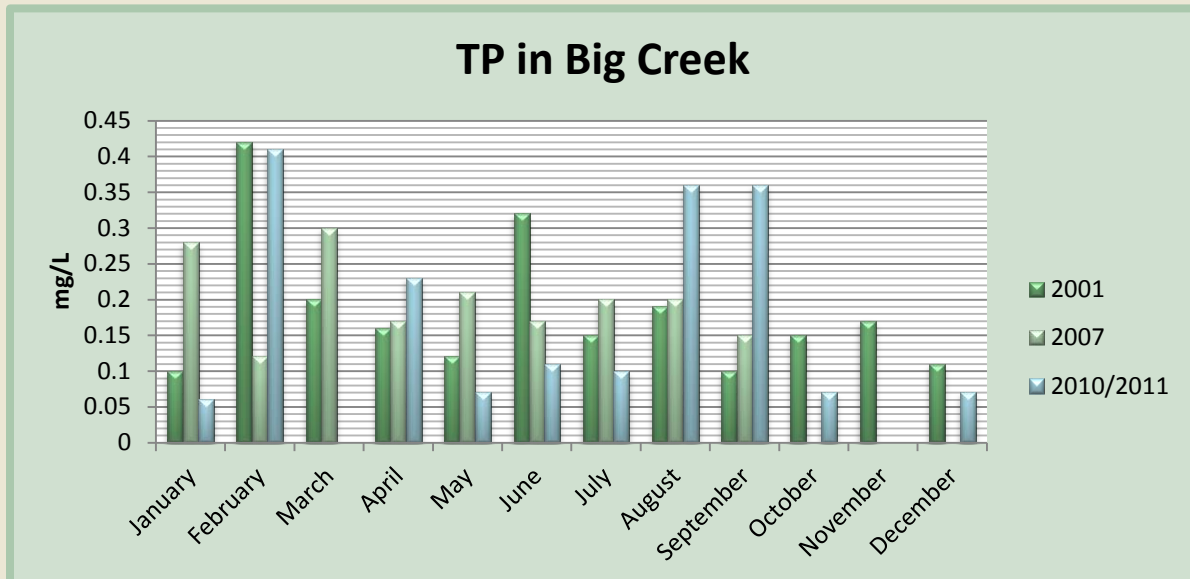
Figure 11: TP in Big Creek 2001, 2007 and 2010/2011

The highest TP value occurred in Big Creek during Feb 2001 (0.42 mg/L) and the lowest values occurred in November 2010 and March 2011.

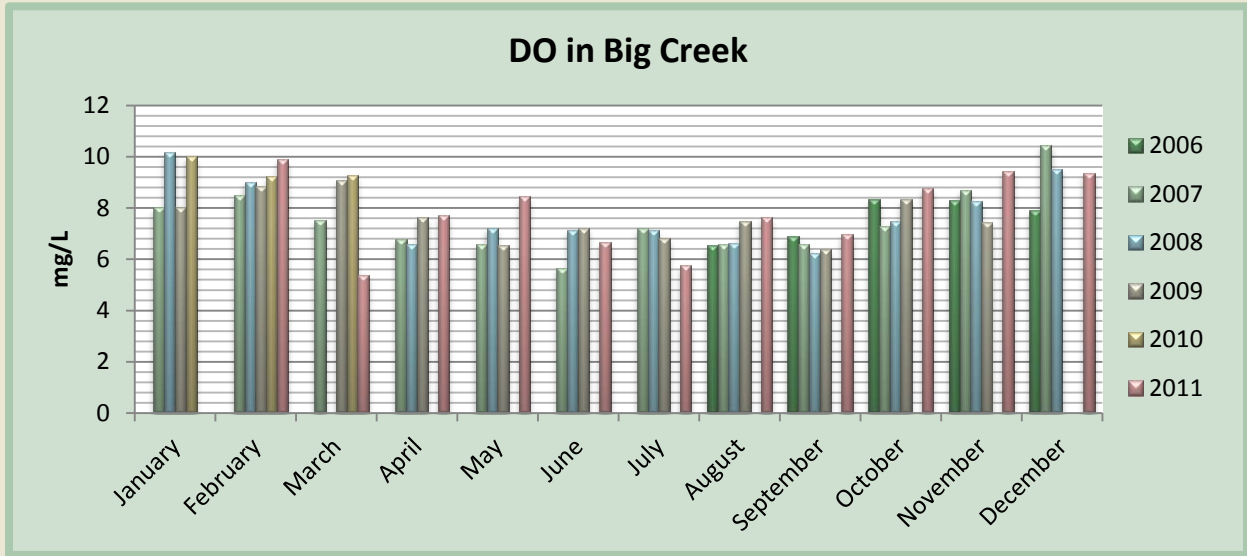
Figure 13: DO Data Collected by LPBF in Big Creek from 2006 to 2011

LPBF's water quality data for Big Creek also indicated DO concentrations were maintained and did not exceed the state's water quality standard of 5.0 mg/L for DO.

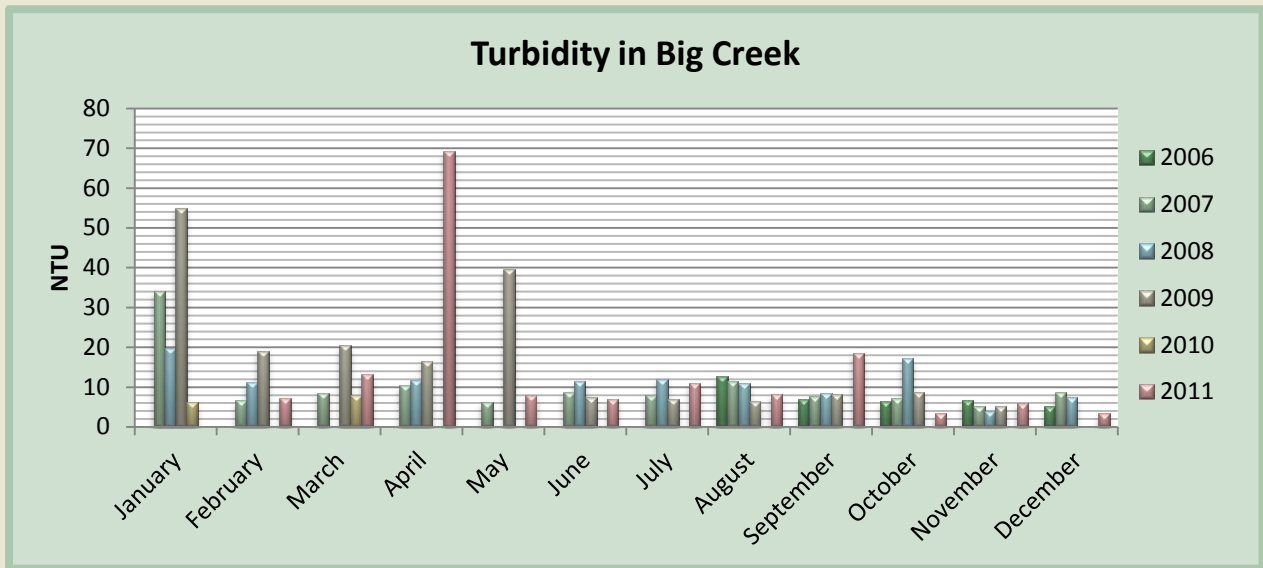
Figure 14: Turbidity Data Collected by LPBF in Big Creek from 2006 to 2011

LPBF's water quality data for Big Creek indicated that turbidity levels were maintained at or below the state's guideline of 50 NTU except during January of 2009 (55 NTU) and April of 2011 (69.19 NTU).

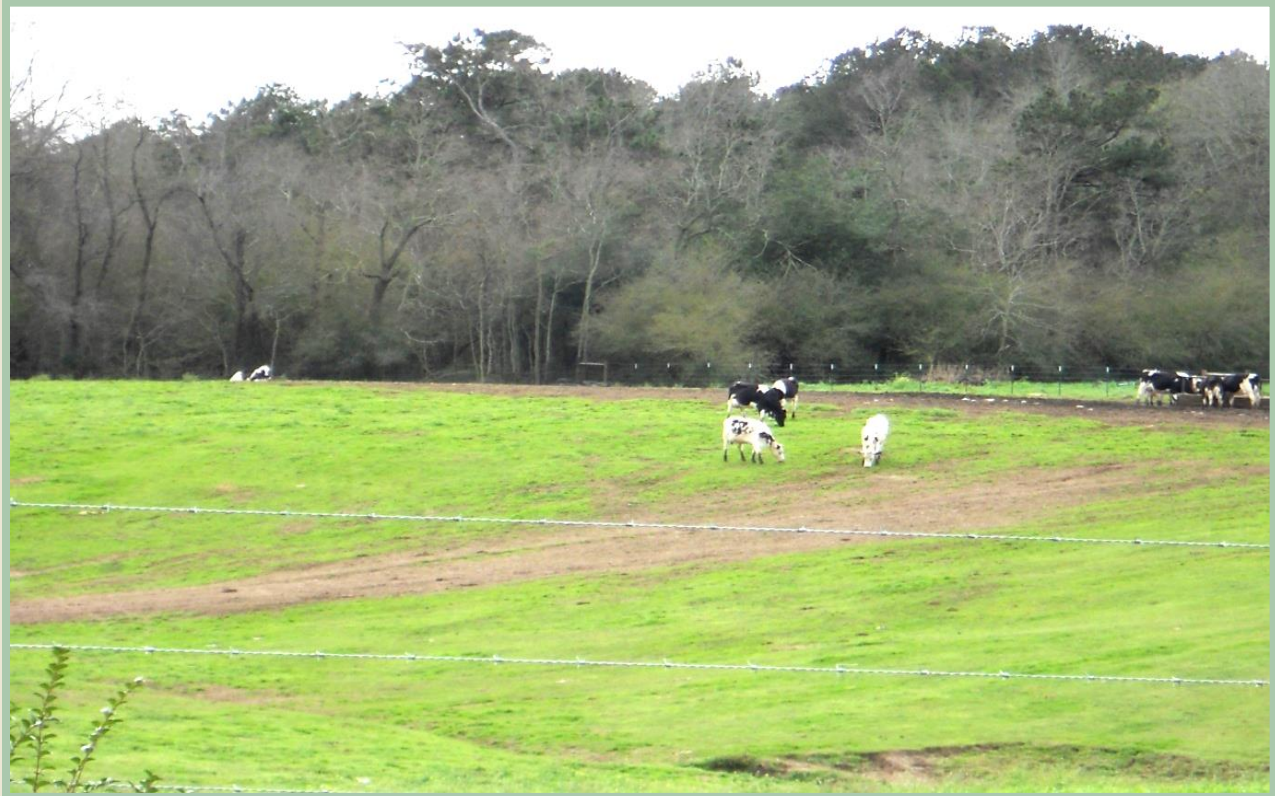
Figure 16: Heavy Use Hay Feeding Area

Figures 16 and 17 represent potential problem areas in Big Creek Watershed. These areas have numerous beef cattle which potentially caused erosion of the hillside. They are heavy use areas utilized for hay feeding primarily during the winter months.

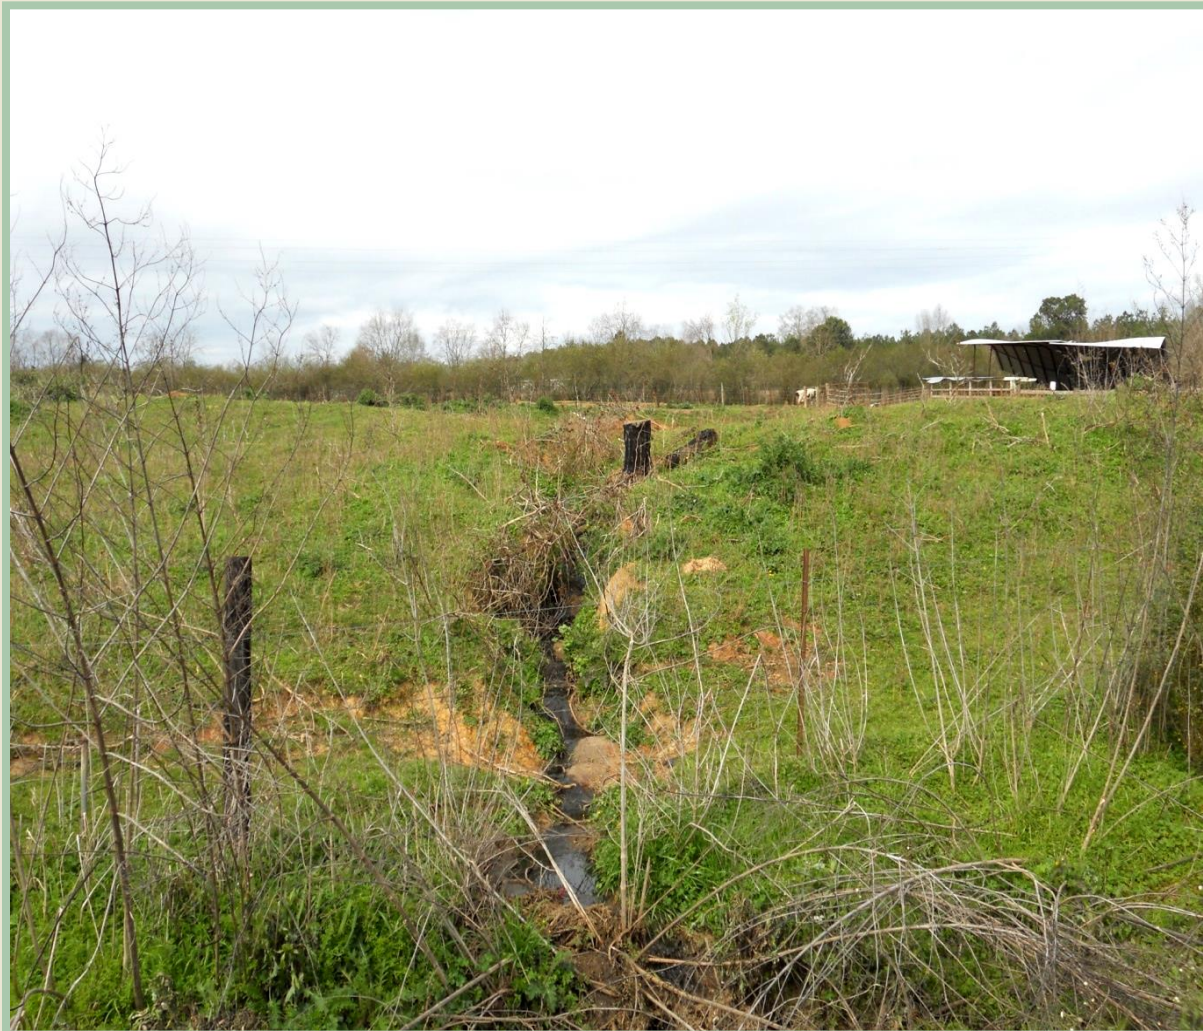
Figure 19: Waste Waters flowing from the Lagoon's Spillway

Figure 19 is a photo taken on a beef cattle ranch in the Big Creek Watershed. It was once a dairy operation that has been converted to a beef cattle operation. This lagoon has a problem, because its walls breached, discharging waste waters to the drainage ditch. As indicated in Figure 19, the types of problems that exist in the watershed include a lagoon with waste flowing out of the spillway. Other lagoons may have similar problems, which should be identified through the RWQA phase of monitoring at 25 locations in Big Creek Watershed.

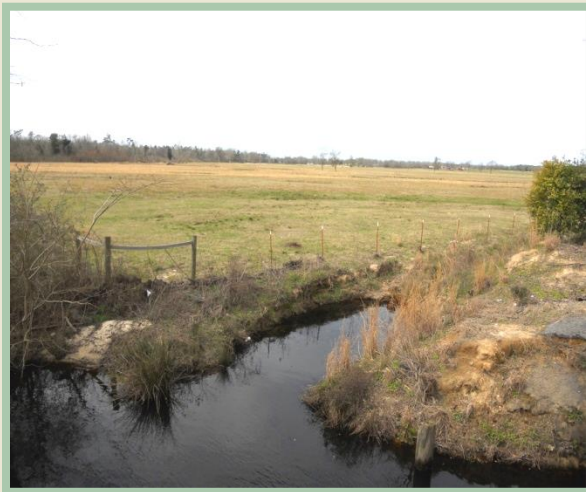
Figure 20: Beef Cows in Area with Fencing too Close to the Stream

There are 22 dairies in Big Creek/East Fork Big Creek watersheds. Approximately six (6) of the 22 are no longer functional and need proper closure. Beef and dairy farms are prevalent throughout the watershed and will be targeted for BMPs through NWQI. One farm that was visited had fencing too close to the creek (see Figure 20), without a buffer between the fence and the stream. Surface runoff from this area would cause high fecal coliform concentrations.

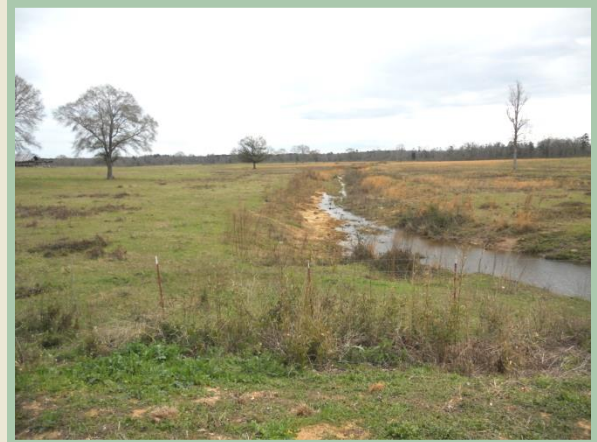
Figure 21: Stream Crossing for Cows without Fencing or BMPs

Figure 21 illustrates an area with beef cows and is another potential site for BMP implementation, such as fencing. There were stream crossings without measures to prevent cows from entering the water way.

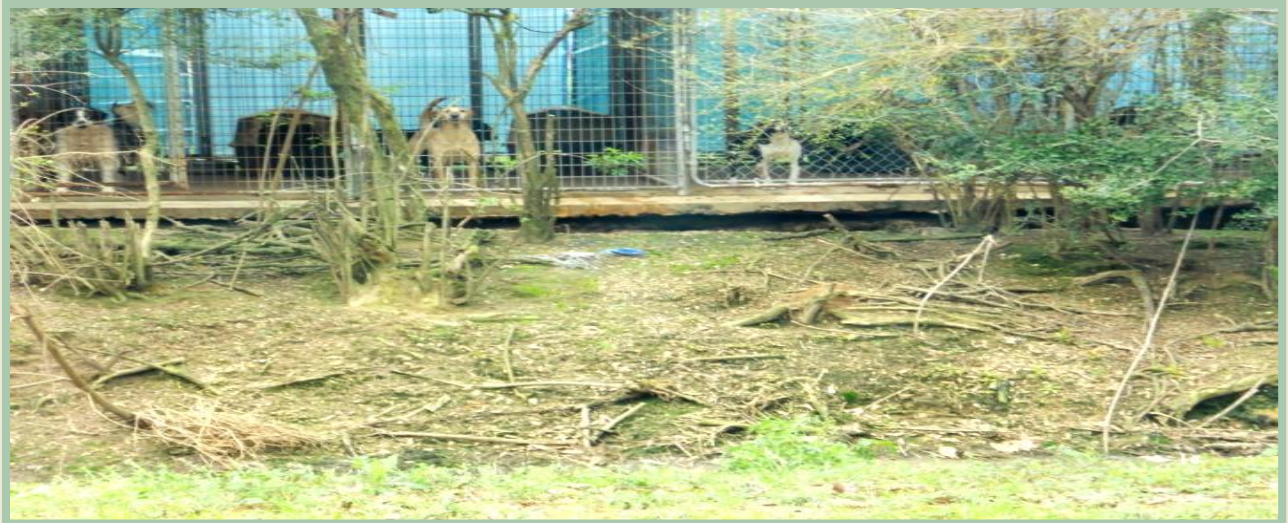
Figure 21: An Animal Shelter in the Watershed

Another interesting issue was an animal facility with numerous dogs. The waste from these animals is being washed into the ditch in front of this shelter and there are signs of erosion along the ditch. The bacteria from waste in the ditch contribute to high concentrations of fecal coliform bacteria.

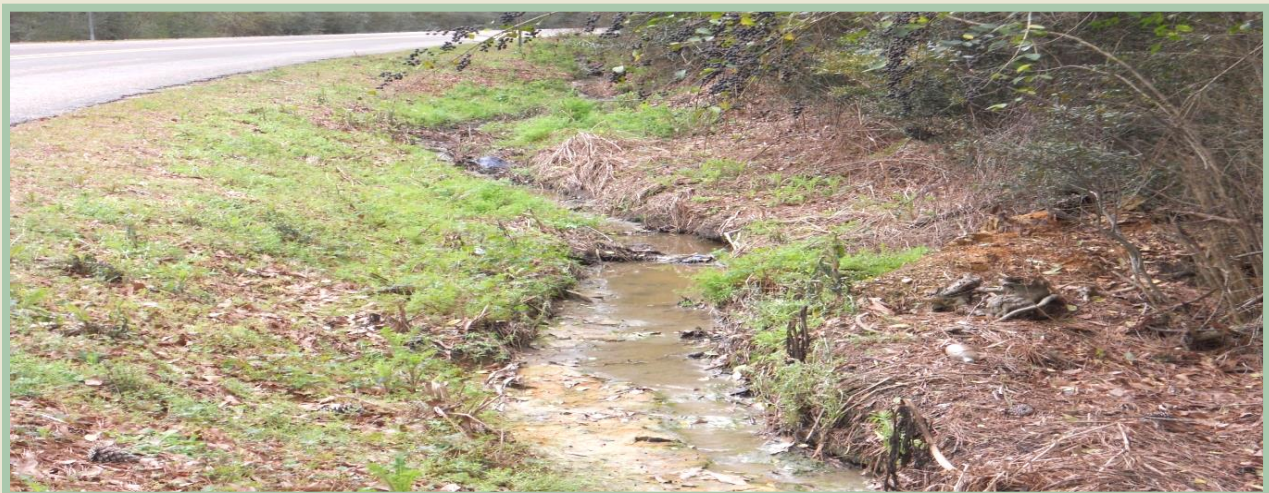
Figure 22: Ditch outside the Animal Shelter

Figure 23 is a ditch located just outside of an animal shelter. The condition of the water in the ditch is indicative of the waste load from an animal shelter.

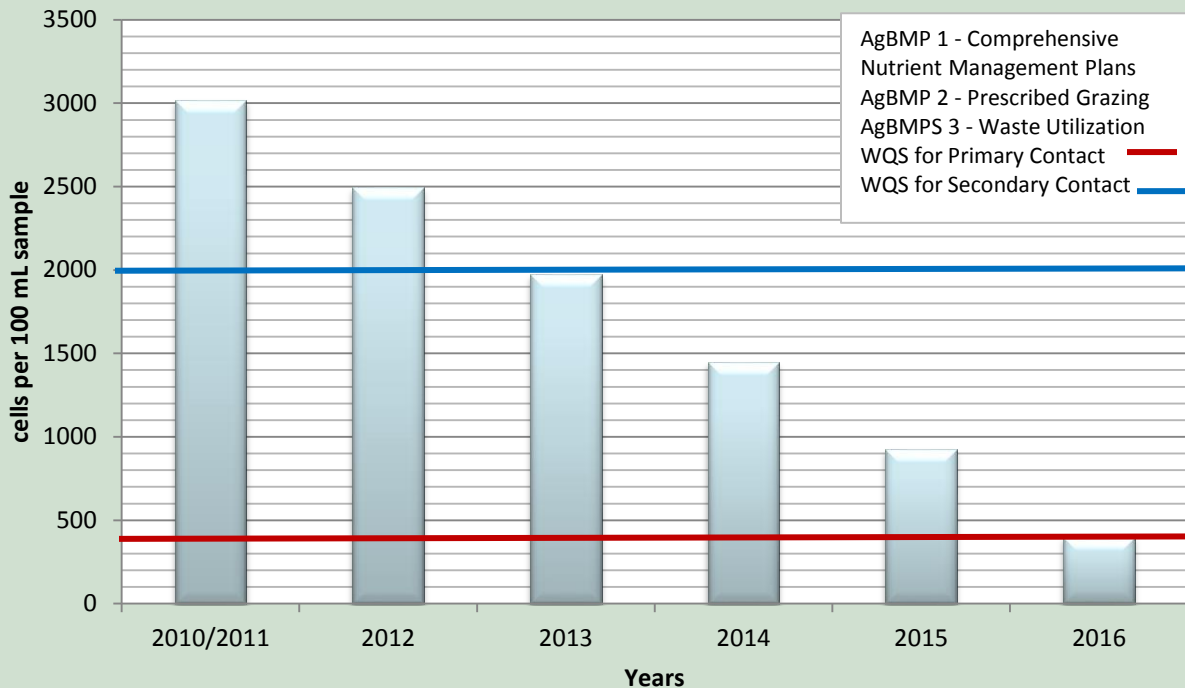
Figure 24: Estimated Reductions of Fecal Coliform in Big Creek

Estimated Reductions of Fecal Coliform due to BMP Implementation in Big Creek Watershed
