MANVILLE FOREST PRODUCTS PLANT 94 SHREVEPORT, LA

The photos on the following pages show the site immediately after, as well as ten months following, the remediation process:

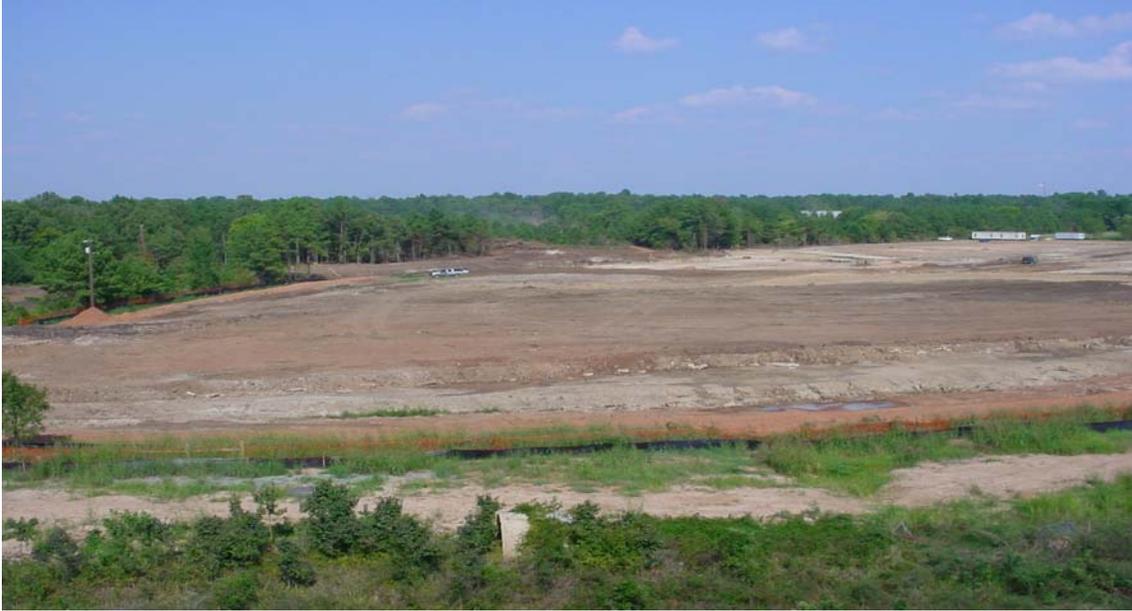
Looking northeast at the site from the Inner Loop ramp to I-49
[Area in the middle is the location of excavated soil]
(9/28/02)

LDEQ approved Remedial Action cleanup activities commenced in August 2002. Contaminated soil was excavated from nine areas within thirty-one acres of the site. Soil samples were collected and analyzed to confirm that the remaining soil in each excavation area met the required RECAP standards for industrial land use. A total of 46,391 cubic yards of excavated soil was placed and contained on six acres located at the western end of the property abutting the KCS and T & P railroad tracks. Excavated areas were backfilled with clean soil from offsite and regraded. The site was then seeded with a mixture of grasses. Excavated contaminated soils consolidated onto the western six-acre parcel were capped with 3 feet of clean clay and topsoil after placement had been completed.

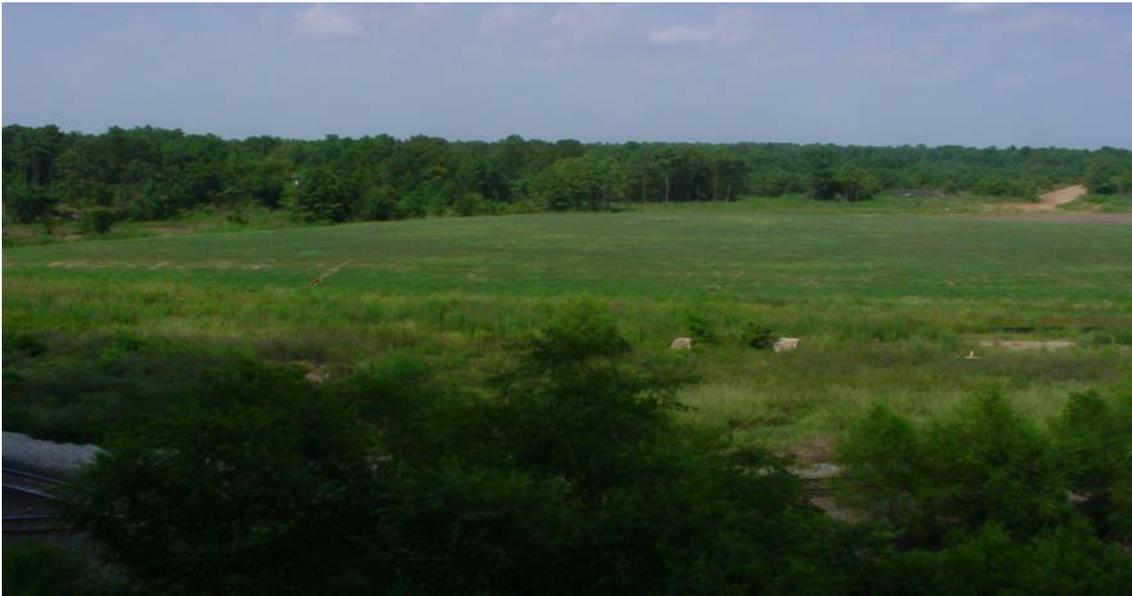
Looking northeast at the site from the Inner Loop ramp to I-49
[Area in the middle is the location of excavated soil]
(7/28/03)

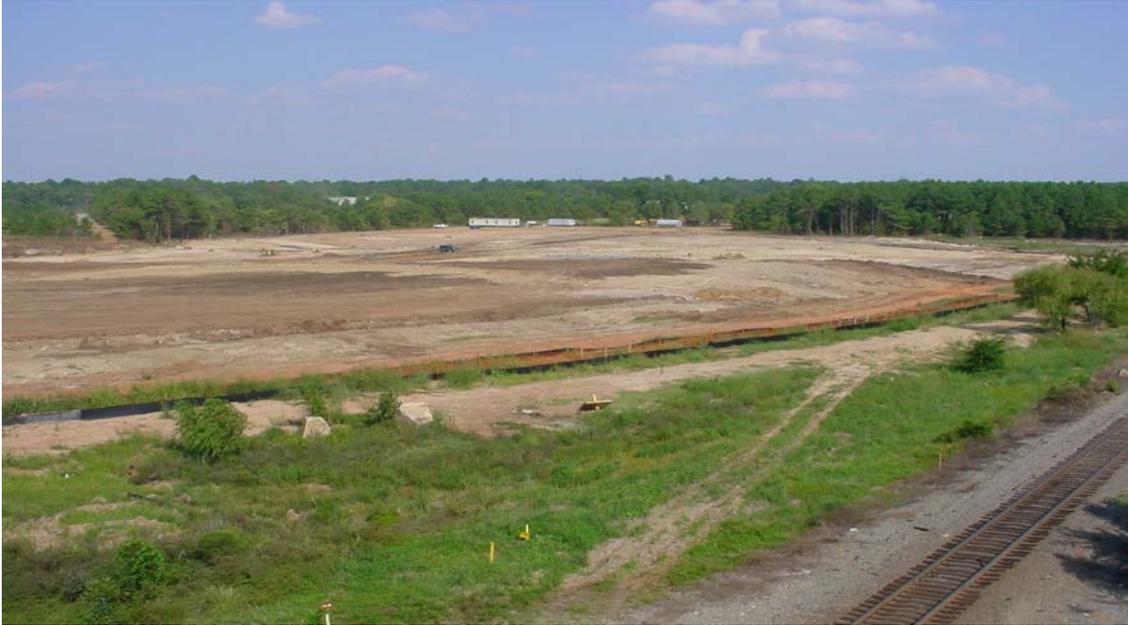
**Looking east at the site from the Inner Loop ramp to I-49
(9/28/02)**

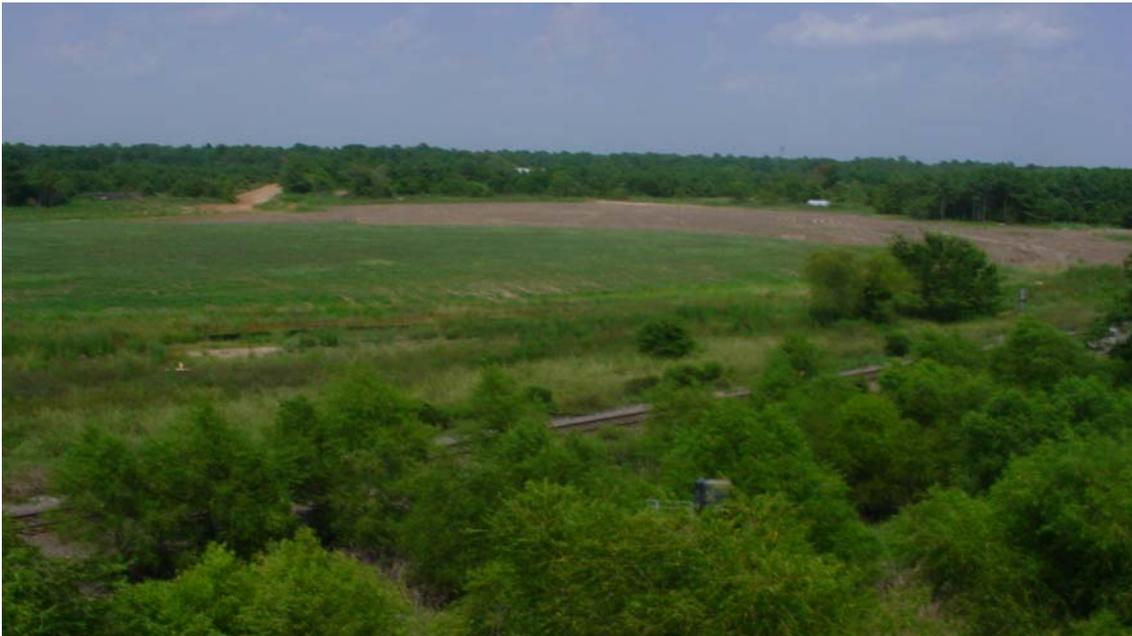
**Looking east at the site from the Inner Loop ramp to I-49
(7/28/03)**

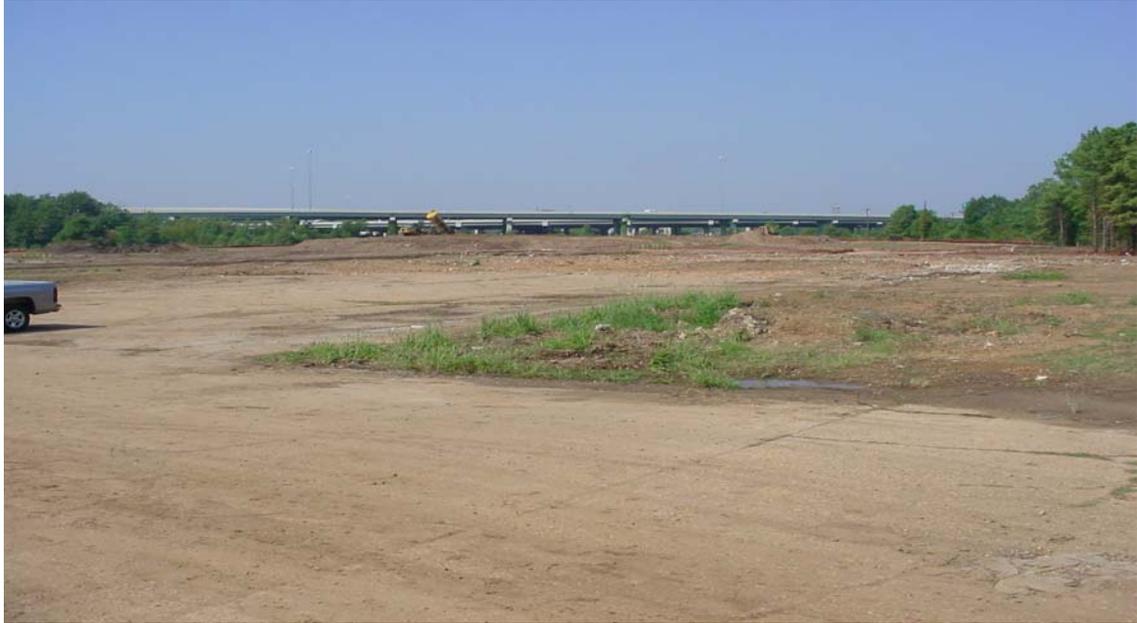
**Looking west towards the Inner Loop ramp from the Trailer
(9/28/02)**

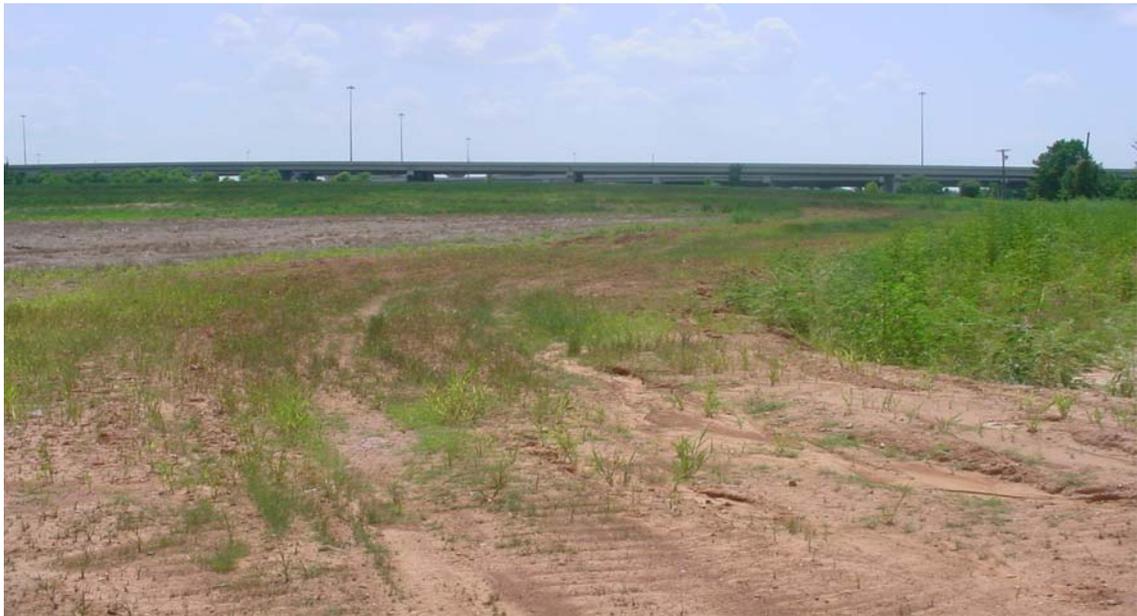
**Looking west towards the inner loop ramp from the area of the trailers
(7/28/03)**
